Energy Savings Assessment

ASSESSMENT SITE
Westmoor Building 2
10155 Westmoor Drive
Westminster, CO 80021

ASSESSMENT PERFORMED BY
Ace Mechanical
1234 Main Street
Denver, CO 80021
(800) 321-1234

ASSESSMENT DATES
01/22/2009 – 01/29/2009

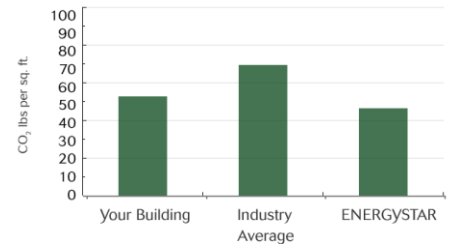
Carbon Footprint

Your building's annual carbon footprint is **2,042 tons of CO₂** or **47.8 lbs per sq. ft.**

Your building's carbon emissions are 12% less than an industry average facility, but could be further reduced by 16 lbs per sq. ft. by achieving an ENERGY STAR score of 90.

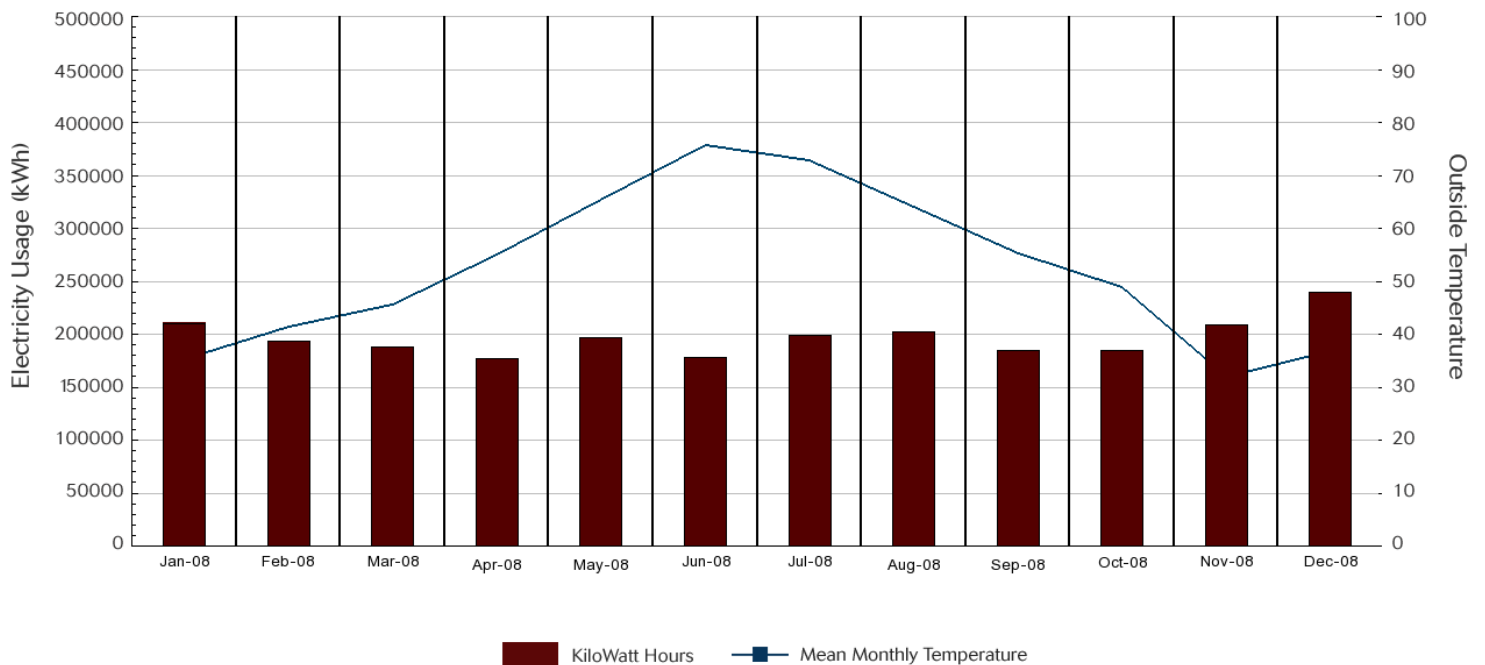
Electricity Consumption And Outside Air Temperature

This page shows how electricity use in your building compares to outside weather and helps identify performance issues in the building. Typically your consumption should track the weather pattern for the type of heating or cooling equipment operating in your building. Overall flat consumption can be indicative of 1) simultaneous heating and cooling, 2) extended fan operation, 3) extensive reheat, and 4) an inefficient lighting system. Be aware, some variation can be caused by estimated meter readings which are “fixed” the next time the meter is actually read

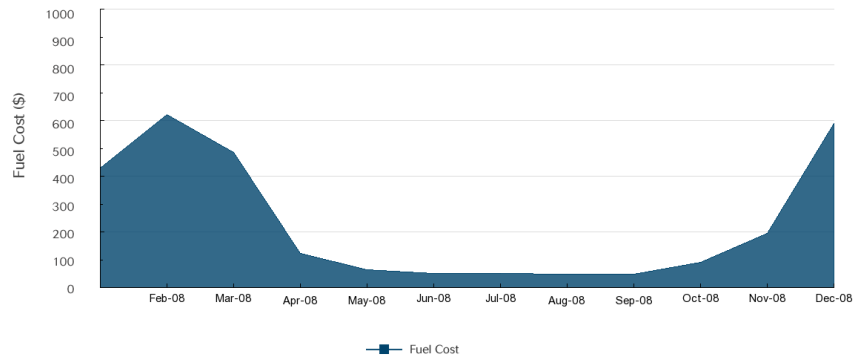
Monthly Fuel Costs

- Fuel comprises 1.3% of your total utility cost, and 3.3% of your total utility consumption.
- Your Total Spend on Fuel is \$2,792.

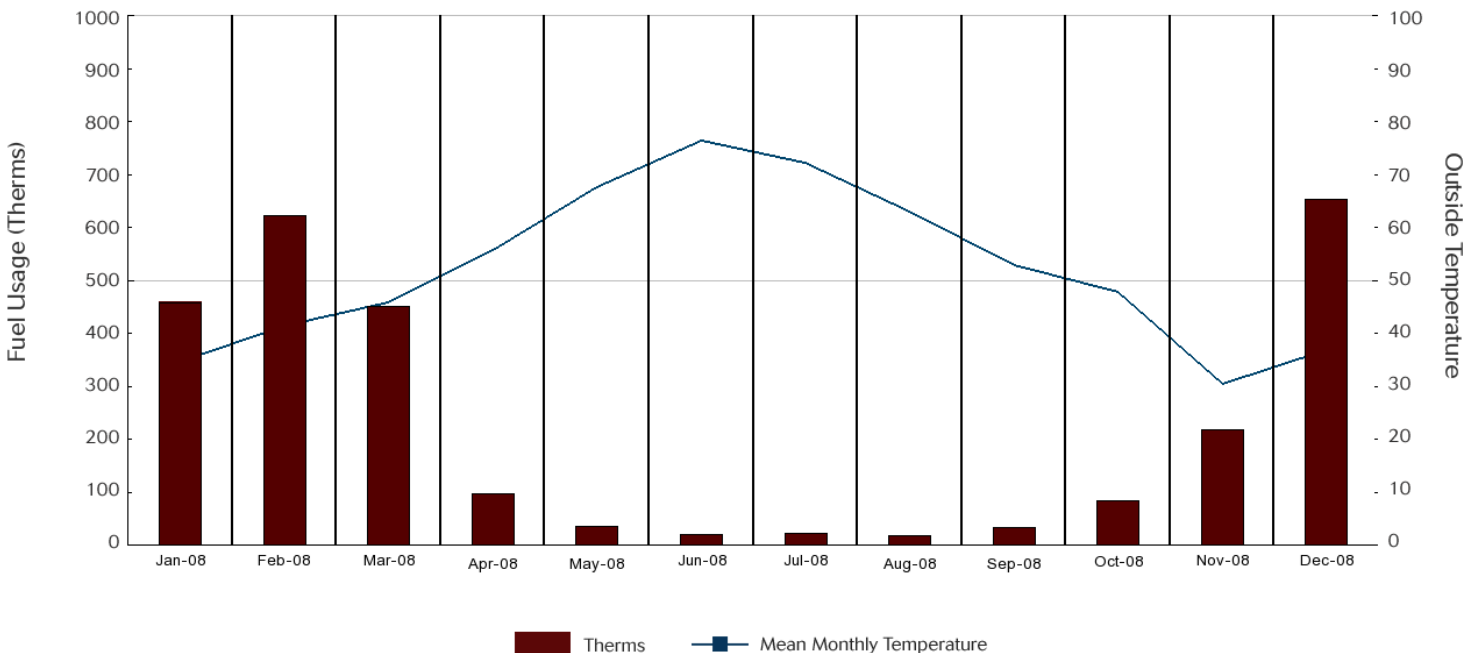
Fuel Consumption And Outside Air Temperature

This page shows how Fuel is used in your building relative to outside weather and helps identify performance issues in the building. Typically your consumption should track the weather pattern for the type of heating equipment operating in your building. Overall excessive consumption can be indicative of 1) simultaneous heating and cooling, 2) extensive reheat, and 3) heating in warmer months. Be aware, some variation can be caused by estimated meter readings which are "fixed" the next time the meter is actually read

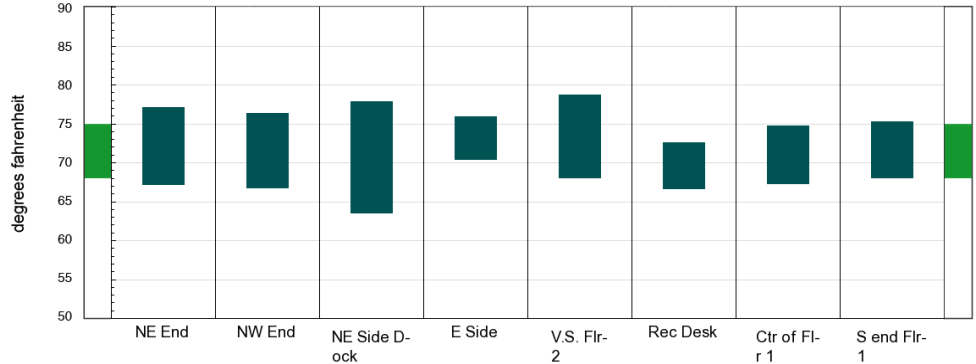
Temperature Findings

Your building is out of control with ample opportunity to save energy.

- 7 space(s) were too warm at times
- 5 space(s) were too cool at times
- 8 space(s) had excessive temperature variation

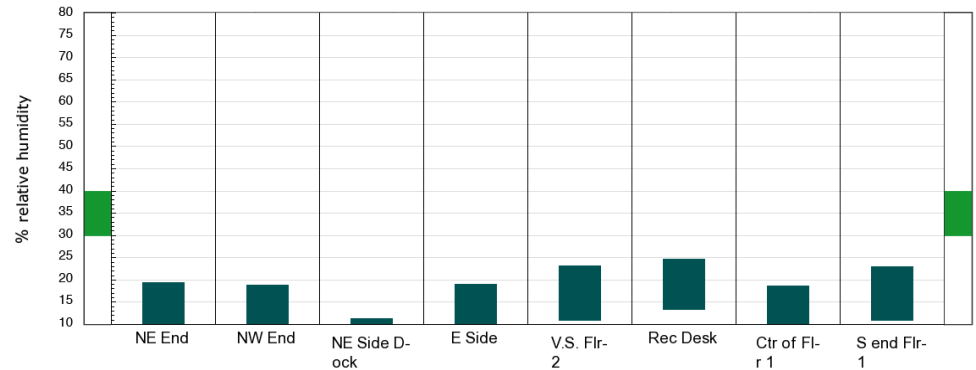
Relative Humidity Findings

- 0 space(s) had high relative humidity at times
- 8 space(s) had low relative humidity at times

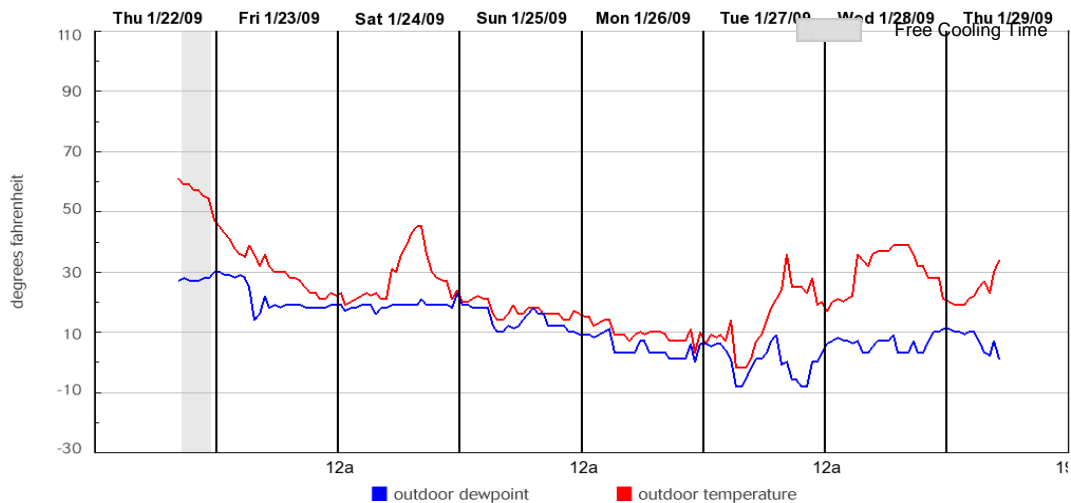
Outdoor Temperature and Dewpoint

This chart shows the outdoor temperature and dewpoint during the test period at the test location.

More aggressive temperature setbacks during unoccupied periods may provide energy savings with no impact on occupant comfort. Proper ventilation control and use of an economizer for free cooling may also contribute significantly to energy savings.

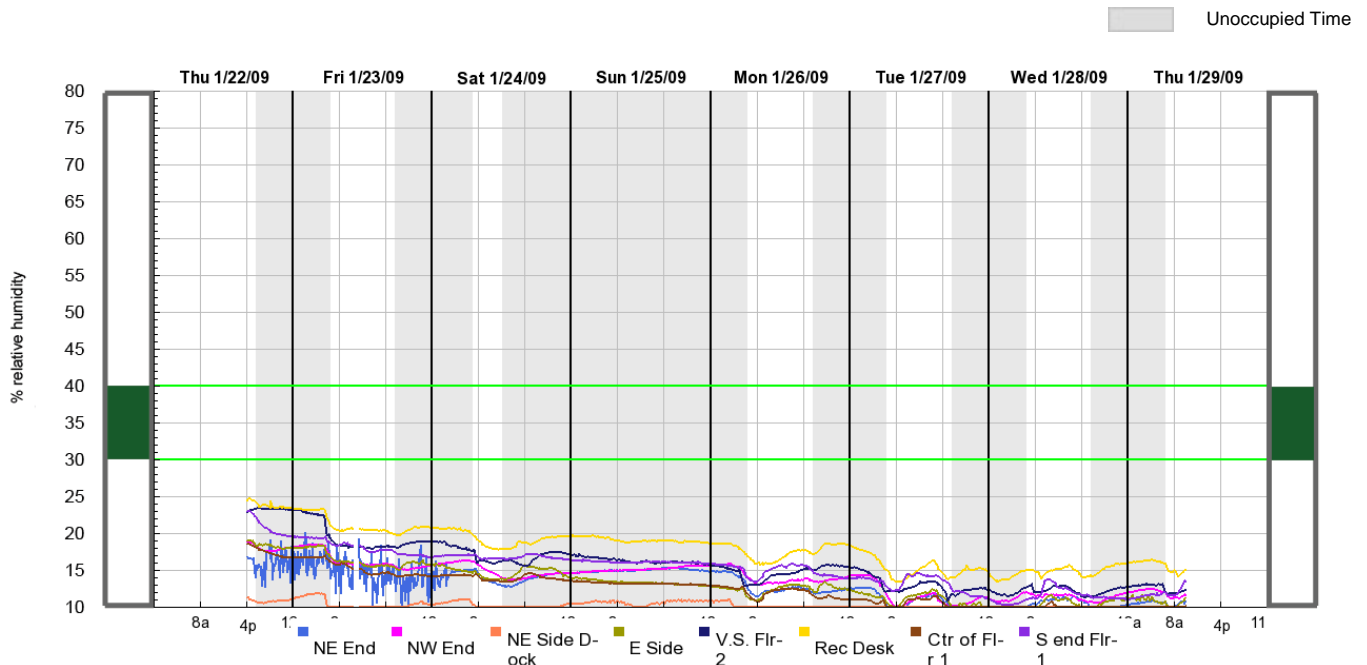
Relative Humidity

Optimum comfort and health is achieved when relative humidity is maintained between 30% and 55%. Readings outside these boundaries may indicate ventilation issues which contribute to an increase of energy used to condition the space.

- No humidification system present
- Excessive ventilation during some periods

Monitor	Alert Lvl	Min	Max	Avg	% ToR*
NE End		9	19	12	100%
NW End		10	19	13	100%
NE Side Dock		1	11	5	100%
E Side		10	19	13	100%
V.S. Flr 2		11	23	15	100%
Rec Desk		13	25	17	100%
Ctr of Flr 1		8	19	12	100%
S end Flr 1		11	23	15	100%

- Add humidification system
- Improve ventilation control

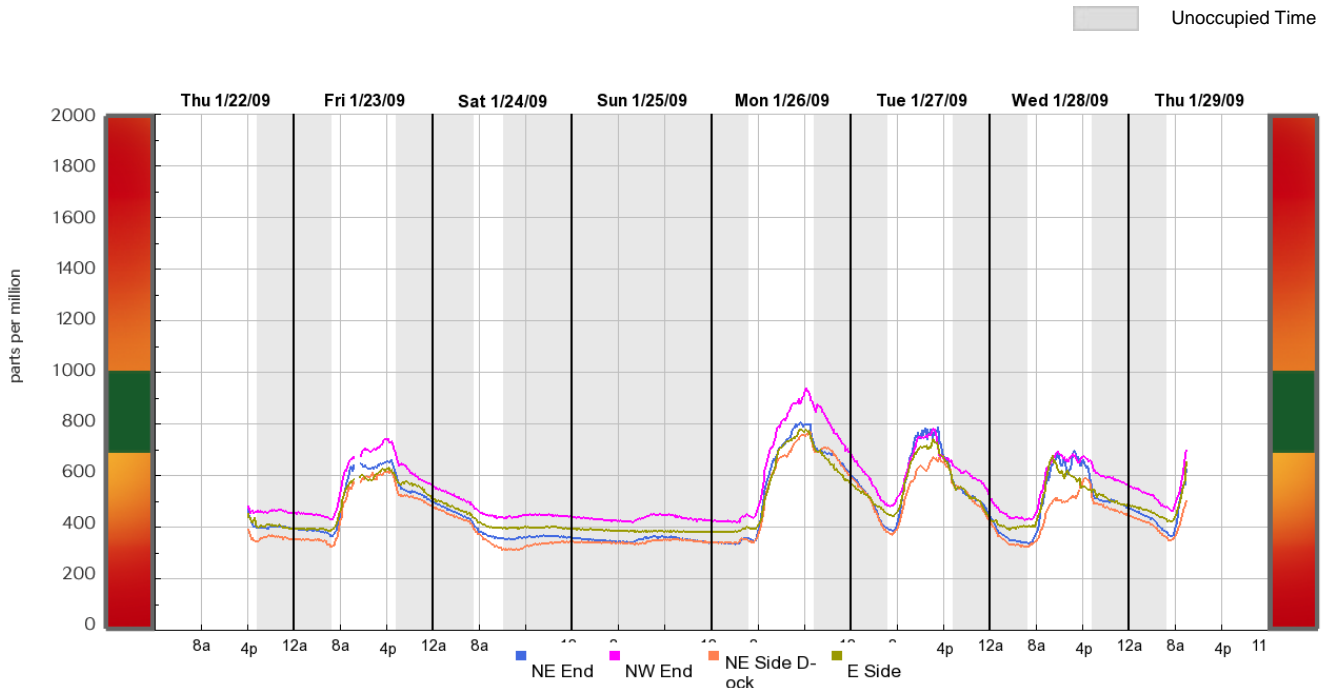
Carbon Dioxide

Monitoring carbon dioxide levels is an important aspect of ensuring a comfortable, healthy and energy efficient indoor environment. At levels above 1000 ppm, air becomes stale and less comfortable to breathe. Levels well below 1000 ppm may indicate excessive outside air, resulting in higher than necessary energy costs due to the need for conditioning of this additional outside air.

Monitor	Alert Lvl	Min	Max	Avg	% ToR*
NE End		335	803	571	82%
NW End		427	935	628	74%
NE Side Dock		312	767	512	94%
E Side		387	775	562	85%

- Verify dampers are not stuck open or leaky
- Reduce the amount of outside air ventilation
- Install demand control ventilation

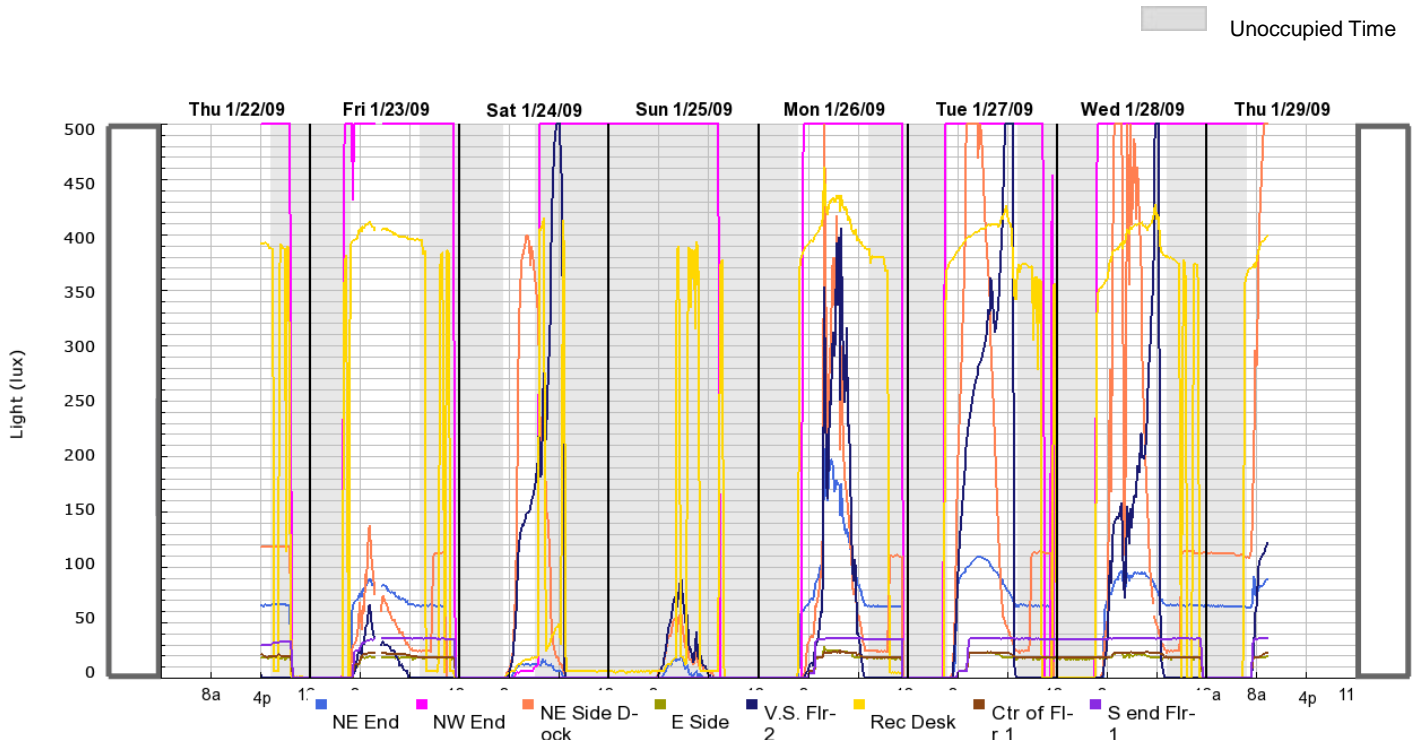
Lighting controls and scheduling are some of the easiest low and no cost investments in energy efficiency. Controlling the artificial lights with occupancy or daylight controls and replacing inefficient bulbs can significantly reduce your electrical energy spend. In the graph below, artificial lights are represented by the sharp on/off of the curve, natural daylight by a gradual increase, and direct sunlight by the large spikes.

Stated Schedule: 13.2 average occupied hours

Monitor	Alert Lvl	Measured On-Time
NE End		11. hrs
NW End		15. hrs
NE Side Dock		7.9 hrs
E Side		11. hrs
V.S. Flr 2		1.6 hrs
Rec Desk		11. hrs
Ctr of Flr 1		10. hrs
S end Flr 1		9.3 hrs

- Verify the light schedule & reduce unoccupied hours operation

- Replace inefficient lamps with new high efficiency lamps
- Install occupancy sensors for individual zones
- Install daylight controls on the perimeter
- Reduce after hours use through coordination with the cleaning crews
